Bulletin: TMIB-0179

Date: July 20, 2011

Topic: Input Shaft Breakage

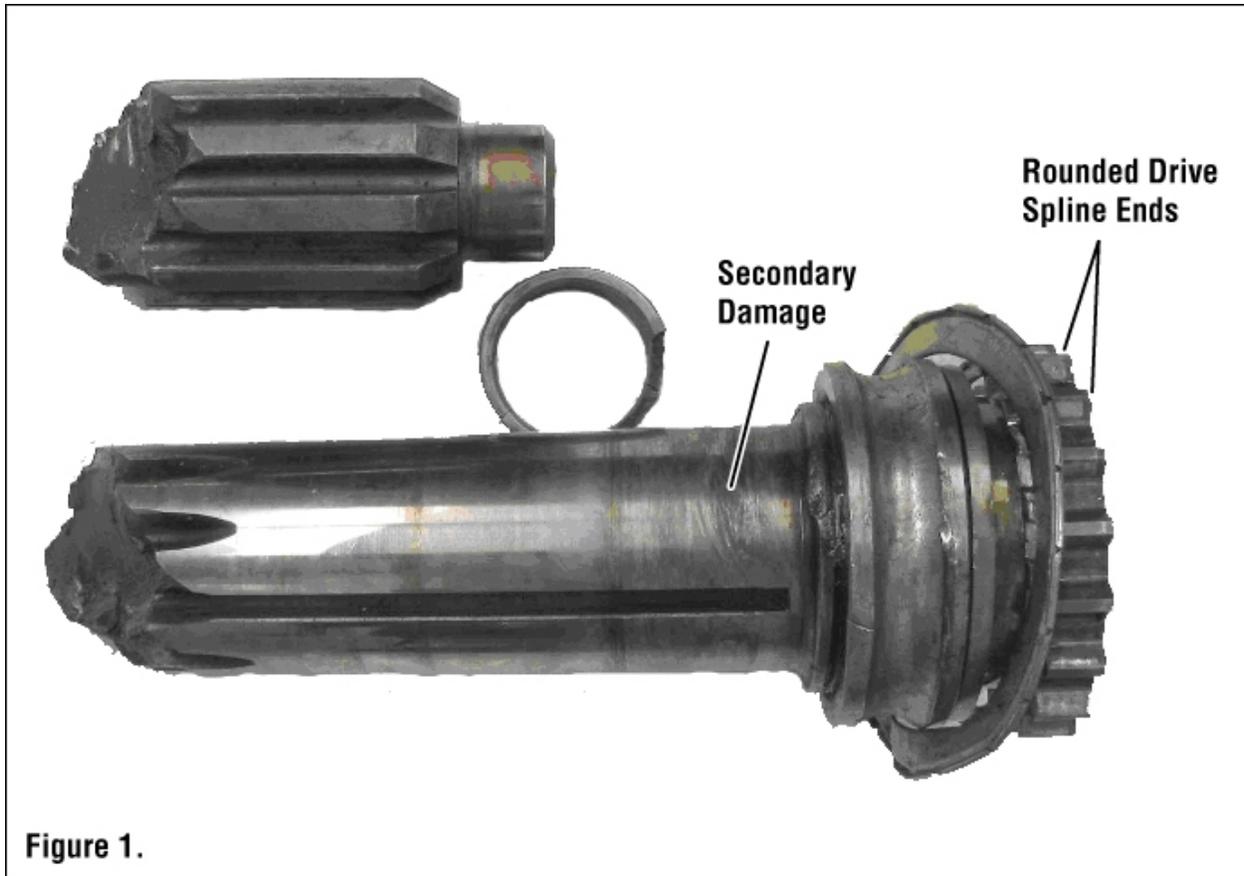
45 Degree Fracture: A 45 degree fracture is the result of an extreme torque spike. The torque spike causes a surface crack which grows over time. As the crack grows, it weakens the shaft until it cannot transfer torque, and fractures. Crack growth can take days, weeks or months before the input shaft fails.

Root cause of a 45 degree input shaft fracture is believed to be aggressive lever shifts or splitter shifts—a shift completed out of the RPM synchronous range for a normal shift. Examples:

- A shift where the lever is forced into gear
- A splitter shift that is not selected properly

Another possible operating condition resulting in a 45 degree fracture occurs when the tandem wheels are spinning and they come in contact with pavement, causing an extreme torque spike. Refer to Figure 1.

Figure 1. 45 Degree Fracture: Typical secondary damage to the shaft diameter just forward of the input bearing. Also, the main drive gear drive spline ends are rounded. This type of fracture (surface initiated torsional fatigue) with the 45 degree helical fracture, often results in secondary damage to either (or both) the engine or transmission. This damage is due to the separating thrust forces—the fracture surfaces act as screw threads forcing the rearward section of the shaft into the transmission case and the forward section of the now failed shaft into the engine flywheel area.

Always use the proper shifting techniques as defined in the driver instructions located in the vehicle, or download online at www.Roadranger.com.

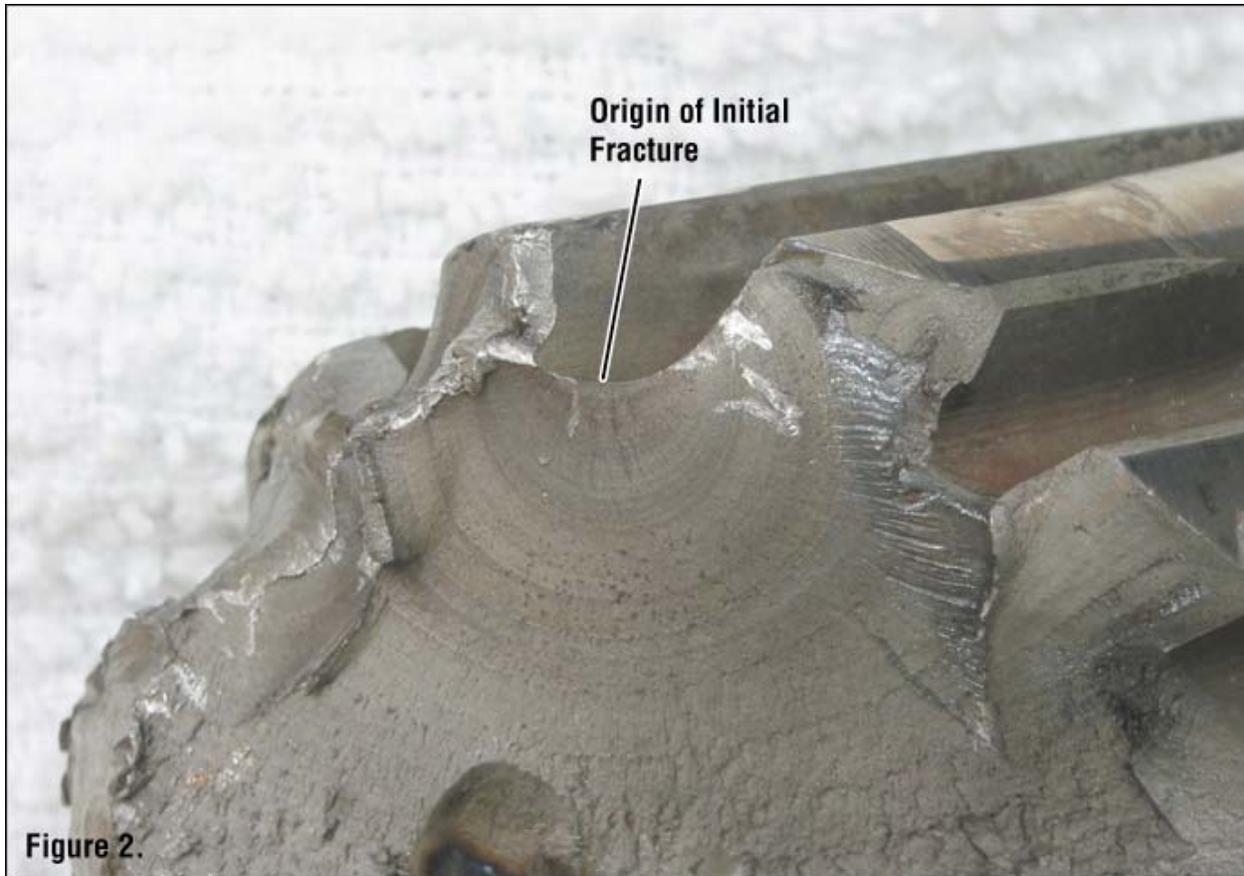
Figure 2. Rearward End of 45 Degree Fracture: A close-up of the rearward end of the fracture—origin of the initial fracture. The fracture began at the bottom of a spline root and progressed slowly across the diameter of the shaft at a 45° angle. The crack grew until the cross section was reduced to a threshold where the shaft could no longer transfer torque and the final fracture occurred.

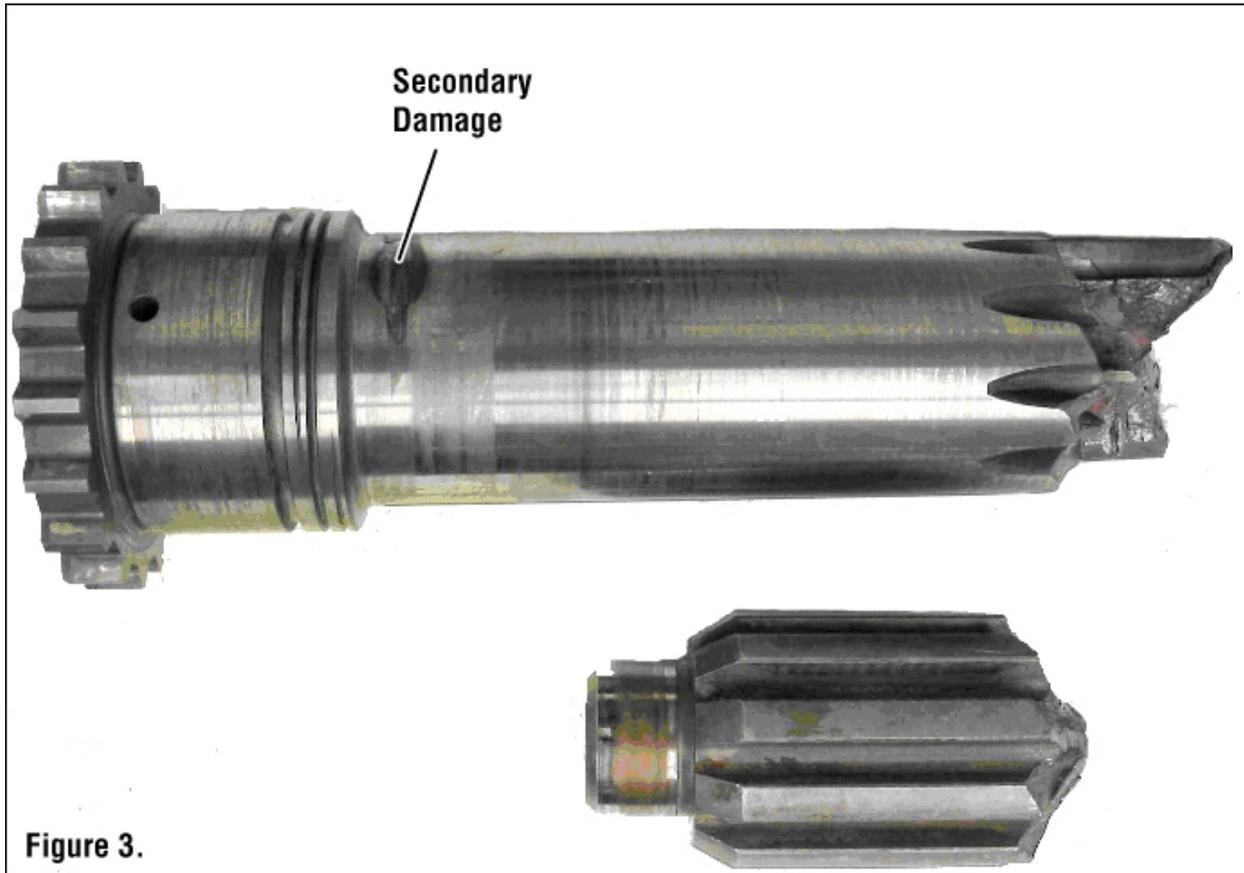
Star Fracture: A star type fracture results from a shaft being subjected to continuous operation at or near the design limit of the shaft strength. Unlike the previously mentioned failure, these cracks often initiate below the surface.

A star fracture is the result of operating the vehicle at the engine's maximum torque for extended periods of time. Refer to Figure 3.

Figure 3. Star Type Fracture: Typical secondary damage caused by the input shaft being driven by the vehicle and flailing around due to lack of restraint. The shaft rubs against the bearing cover resulting in severe scoring on the shaft diameter just forward of the input bearing.

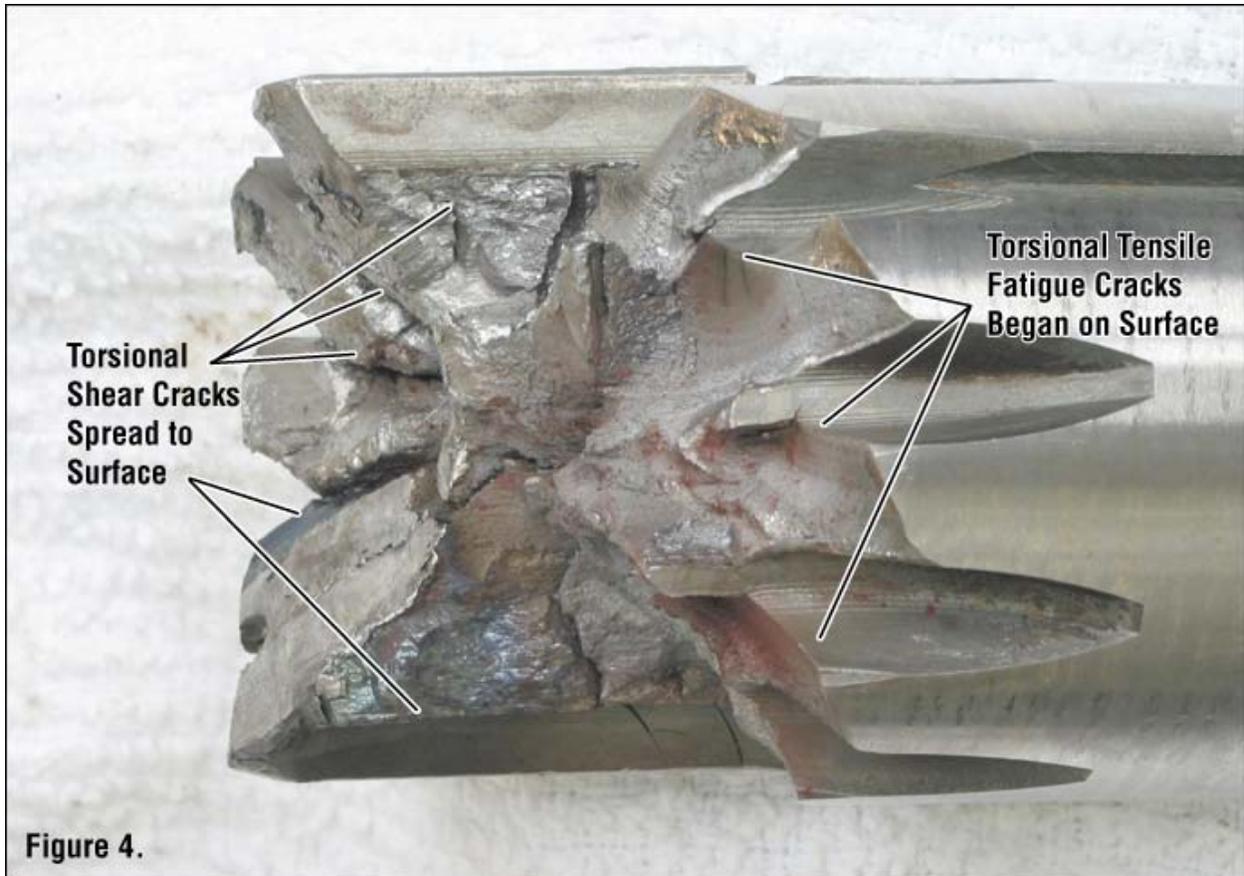
Figure 4. Rearward End of Star Type Fracture (Side View 1): The area rearward of the clutch engagement area, forward of the end of spline full depth, is the area of highest stress on the shaft. There are multiple torsional shear cracks that began internally and spread to the surface where they were connected by torsional tensile fatigue cracks which began at the surface.

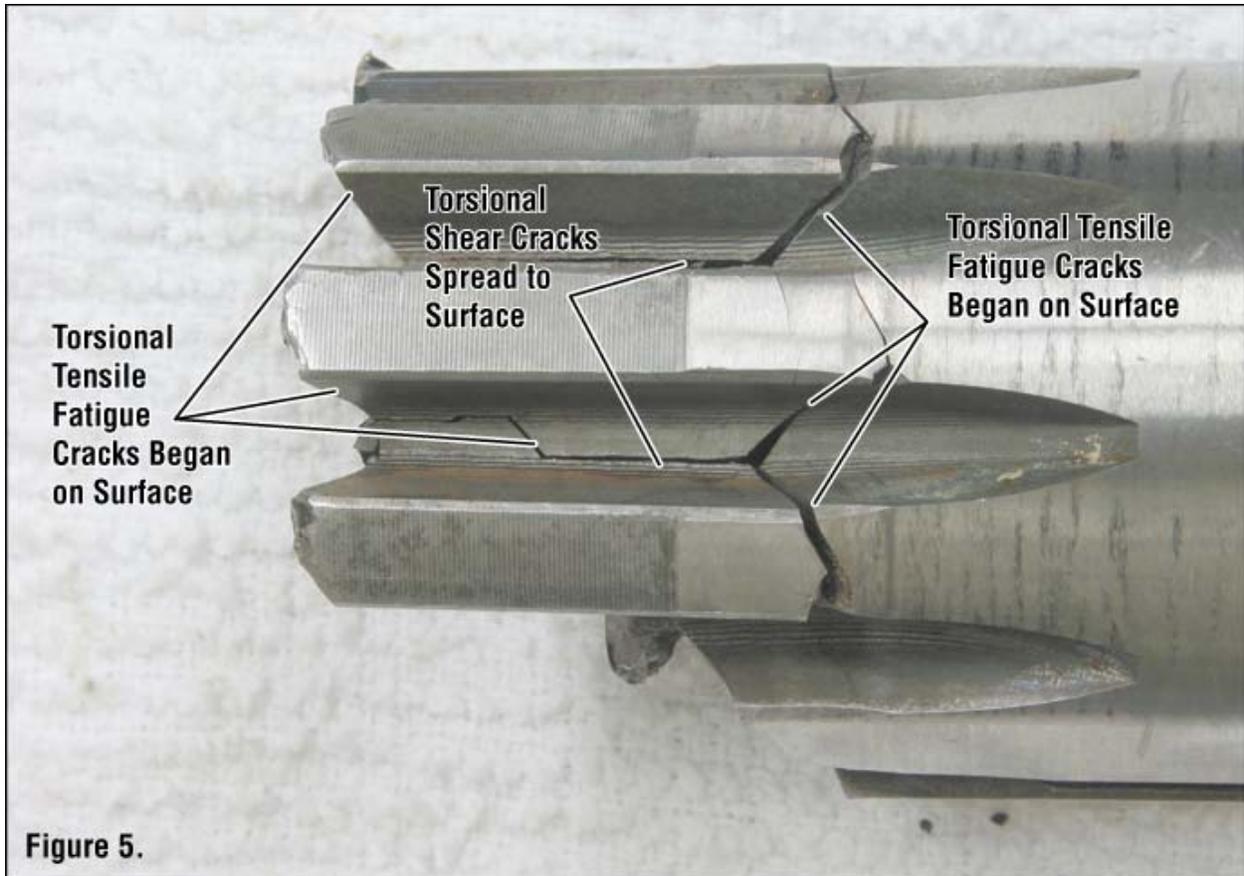
Figure 5. Rearward End of Star Type Fracture (Side View 2): Same area as Figure 4, rotated 180 degrees. The torsional shear cracks and surface initiated torsional tensile fatigue cracks are visible. Torsional tensile fatigue cracks from the surface connect with internal torsional shear cracks, leaving the 'starry' type fracture. See Figure 6.

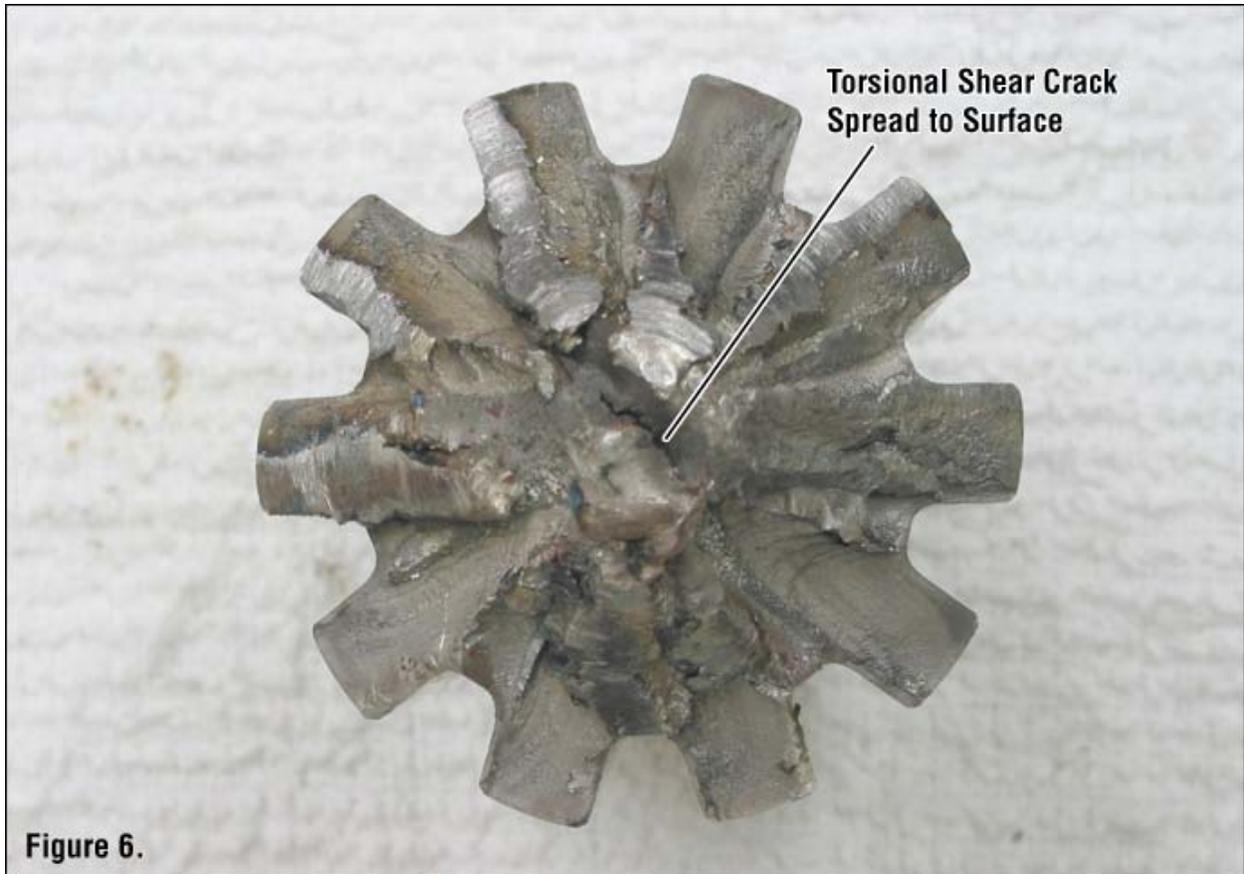
Figure 6. Forward End of Star Type Fracture (Cross Section): A cross section of the forward end of the fracture shown in Figures 4 and 5. Torsional shear cracks often initiate below the surface of each spline, extending to the surface and center of the shaft.
