Subject: Heat Exchanger Failure Causing Transmission Lube Contamination / Flush Procedure

Document Number: TMIB0124

Service Bulletin – Product

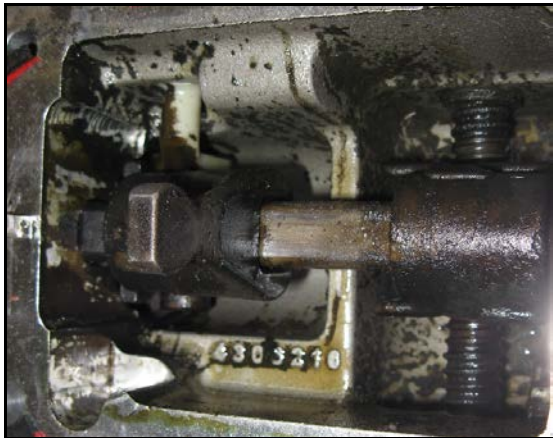
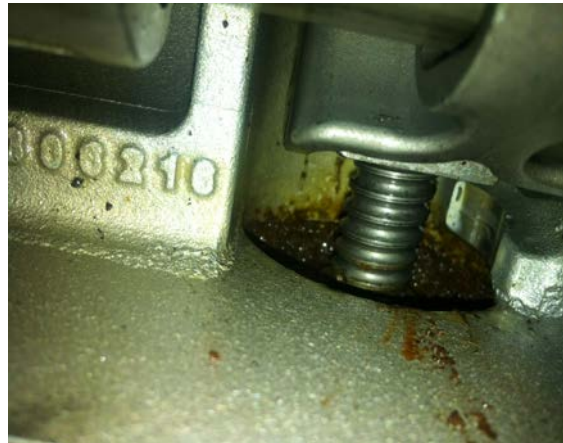
Inspect XY shifter for sludge build up and corrosion around the ballscrew to motor connection.

9. Remove the bottom 8-bolt PTO cover to inspect transmission for damaged gearing and proper flush of contamination. (Remove the oil cooler cover assembly on FR-Series transmissions with internal coolers. Replace cooler before reinstalling cover assembly.)
10. Reinstall the PTO cover using a new gasket; fill the transmission with approved synthetic CD-50 lube.
11. The XY shifter on automated transmissions must be removed and inspected for sludge build-up and corrosion damage after the flush procedure has been completed. Replace complete assembly as needed.
12. Refer to engine OEM for service procedure if engine coolant system is contaminated with transmission lubricant.
13. Replace the heat exchanger, reconnect oil hoses and driveline. Test drive vehicle and inspect for transmission lube or engine coolant leaks.

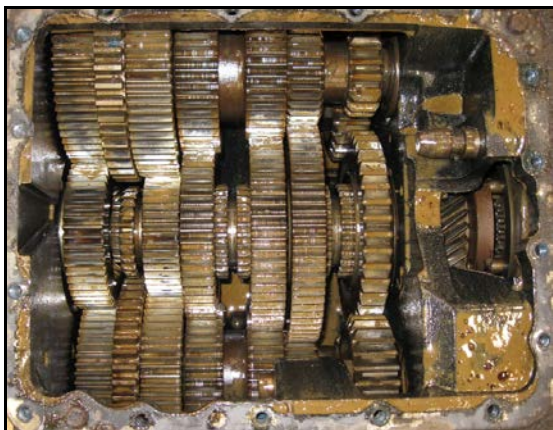
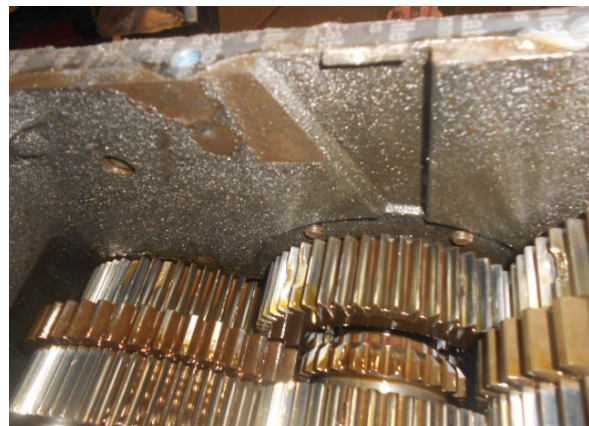
Heat exchanger failure causes engine coolant to enter the transmission case and mix with the lubricant. A flush procedure is required to clean contamination from the transmission as a part of the heat exchanger replacement.

Contamination caused by engine coolant entering the transmission.

1. Drain contaminated lubricant from the transmission.
2. On units with externally mounted heat exchangers, disconnect both oil hoses at the heat exchanger and connect them using an SAE 37° flare union fitting with 7/8"-14 threads. (FR Series transmissions with internal coolers use either 3/4"-16 UNF-2B or 1/2" -14 NPTF at the coolant hose to transmission case fittings.)
3. Fill the transmission with Dexron automatic transmission fluid.
4. Disconnect the driveshaft at the output yoke end of the transmission.
5. Block the vehicle tires and set air brakes to ensure the vehicle does not move.
6. Place transmission in the appropriate gear per reference table below. (On automated models, place the transmission in Manual mode and use the up shift button to select the appropriate gear.)
